Hurricane Tomas Emergency Recovery
Project

Hydraulic assessment for flood risk assessment in Soufrière, Fond St Jacques and Dennery

Report # 1: Site characterization, Flood Hazard and Vulnerability Analysis

December 2013

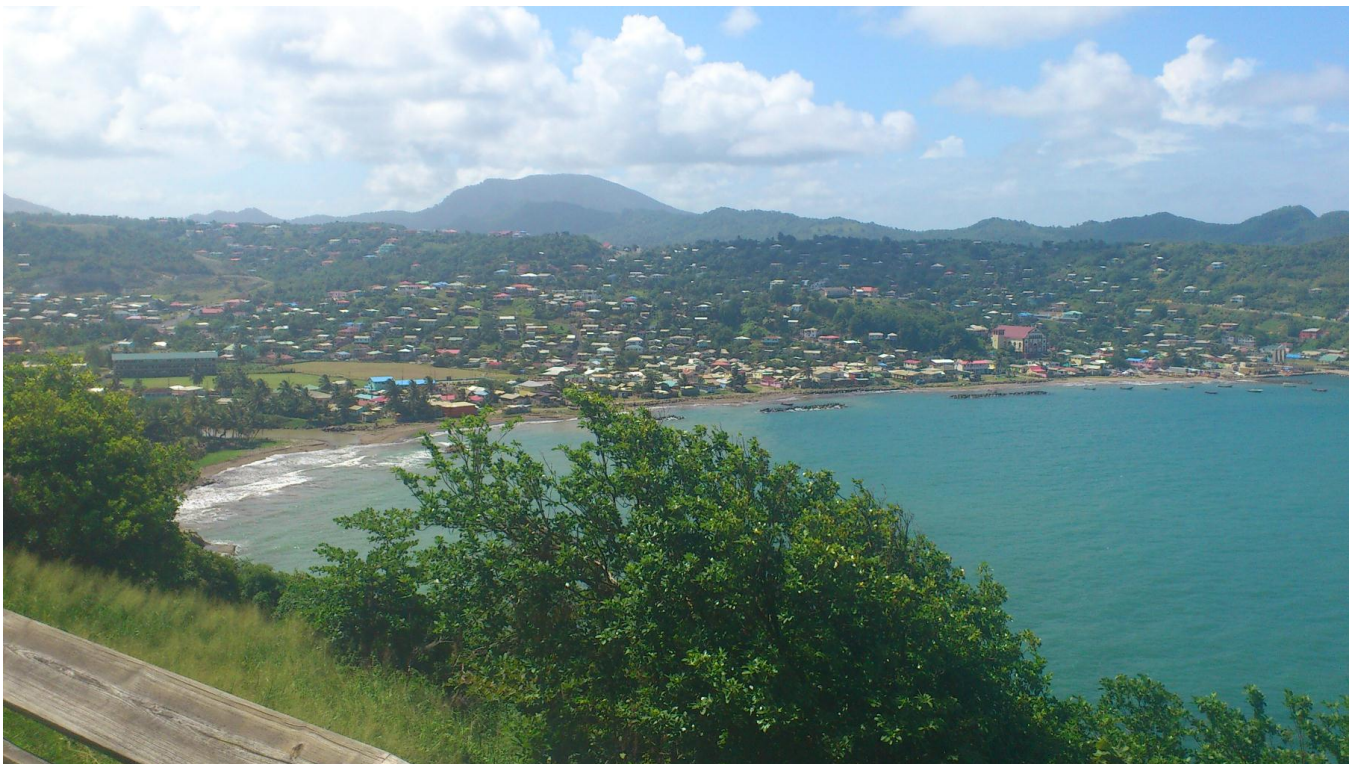
Figure 8 : *Dennery flood plain, urbanized hills and mouth of the Mole River*

The urbanization is growing year by year and is unplanned. This leads to increase soil sealing, and therefore increase runoff. The rain drains developed in the 50's seems to be now undersized. More, some former wetlands, which used to retain and store rain water, are now filled.

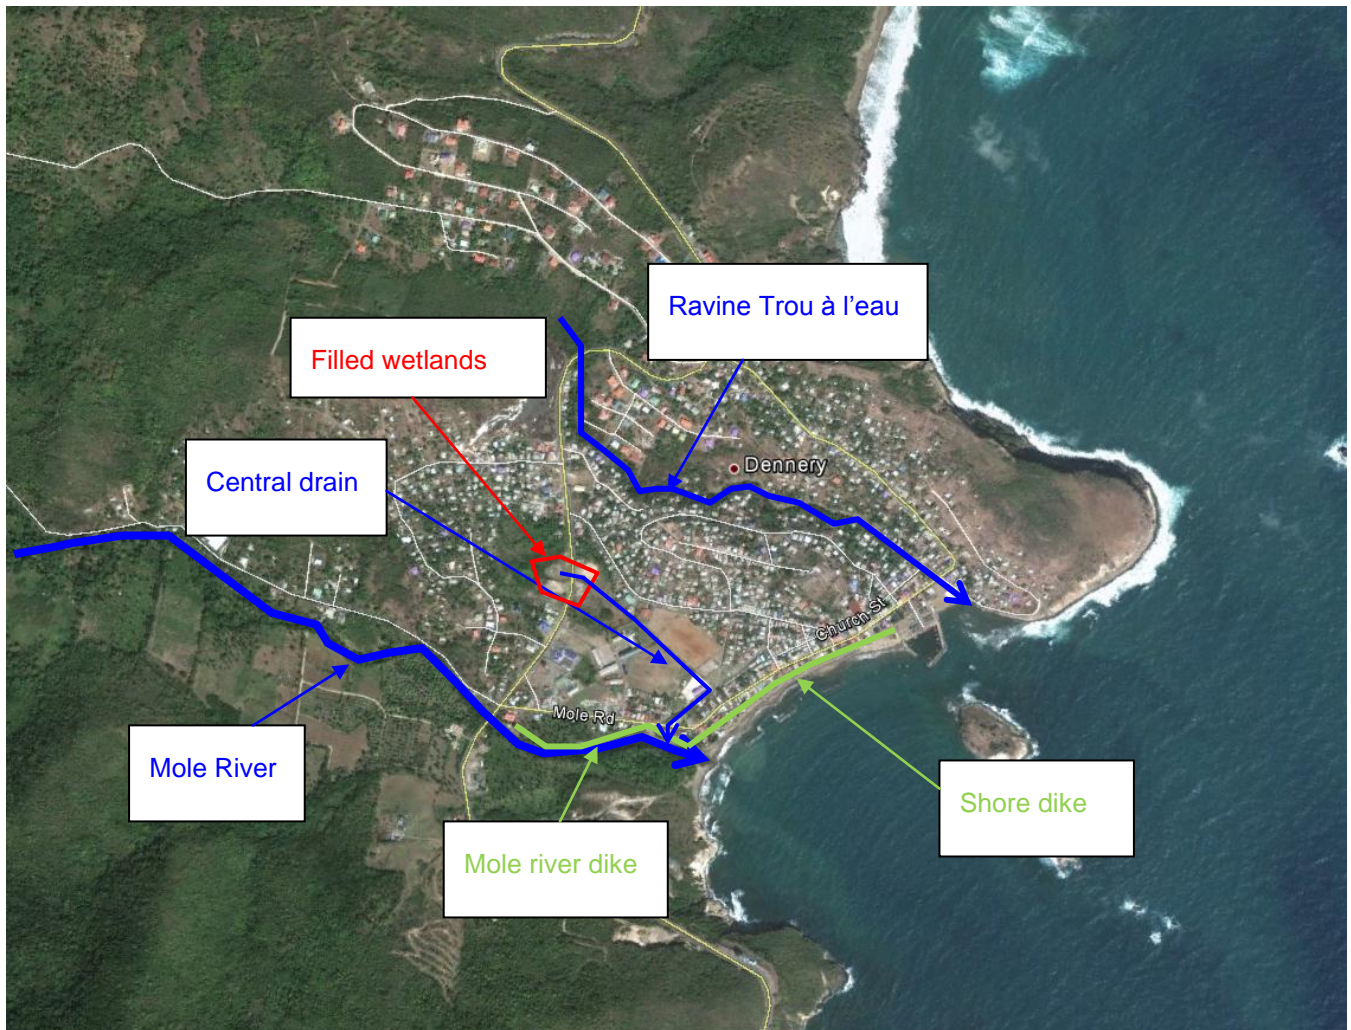
Figure 9 : Dennery drainage system

The Ravine Trou à l'Eau is natural, steep sloped and sinuous upstream, but is a concrete flat drain as soon as it reaches the flat zone downstream. We could see a lot of connection there between the ravine and rainwater network without any anti-backflow system. This may create flooding more often in the neighbourhood when the upstream catchment is having a heavy rain. A lot of bank erosions have been seen during our investigations in the natural part of the ravine : the speed of water there must be high.

In addition with flooding problem we could see a health problem: rainwater network (almost 100% with open channel) is used as a sewer by the citizens. In case of over flooding, it can be a cause of illness.

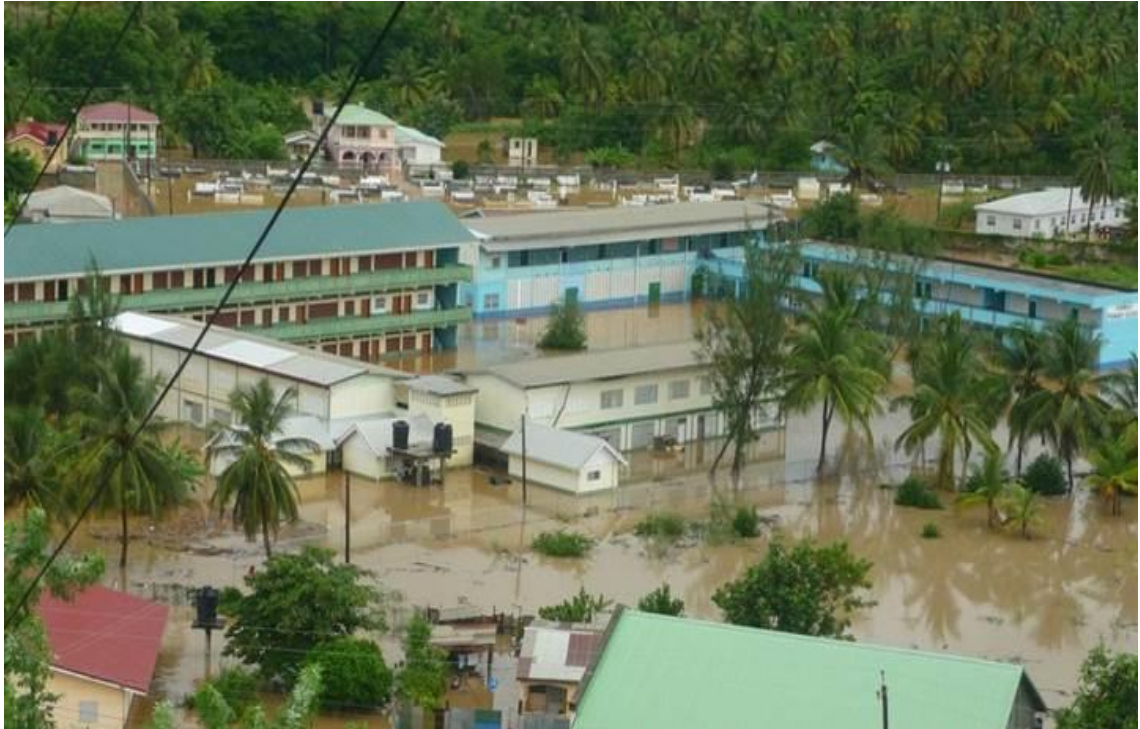
Figure 10 : Photography of Dennery Primary School during Tomas (cimetary in background)

The first one shows the schools during flooding. The second one corresponds to the Mole Road (first road after the dike) after flooding. We can see the presence of lot of mud.

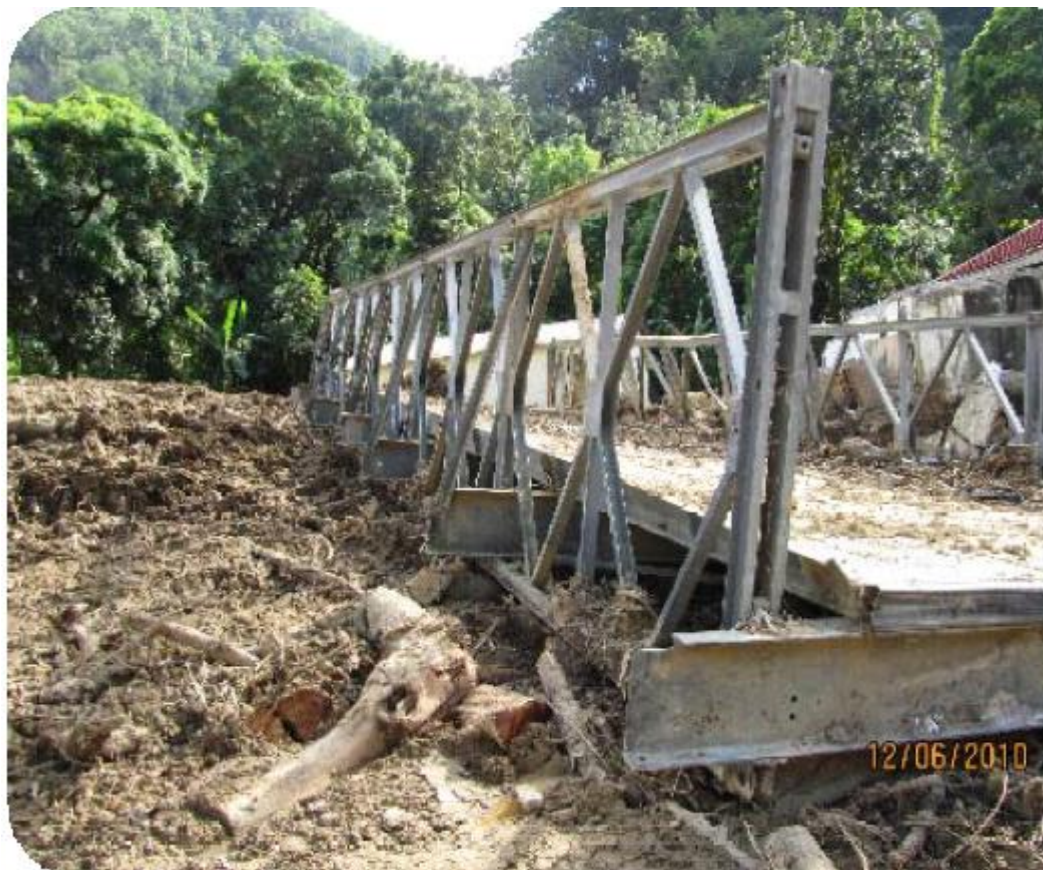
Figure 28 : photography of Fond Saint Jacques upstream bridge (road to Migny)

Debris flow provided big jams problem under each bridge across the river as we can see on the next photographs:

Those huge quantities of mud, trees and rocks came from important landslides in the upper forest reserve and are a consequence of 24 hours raining (550 mm registered in Union and 593 mm in Hewanorra Airport).

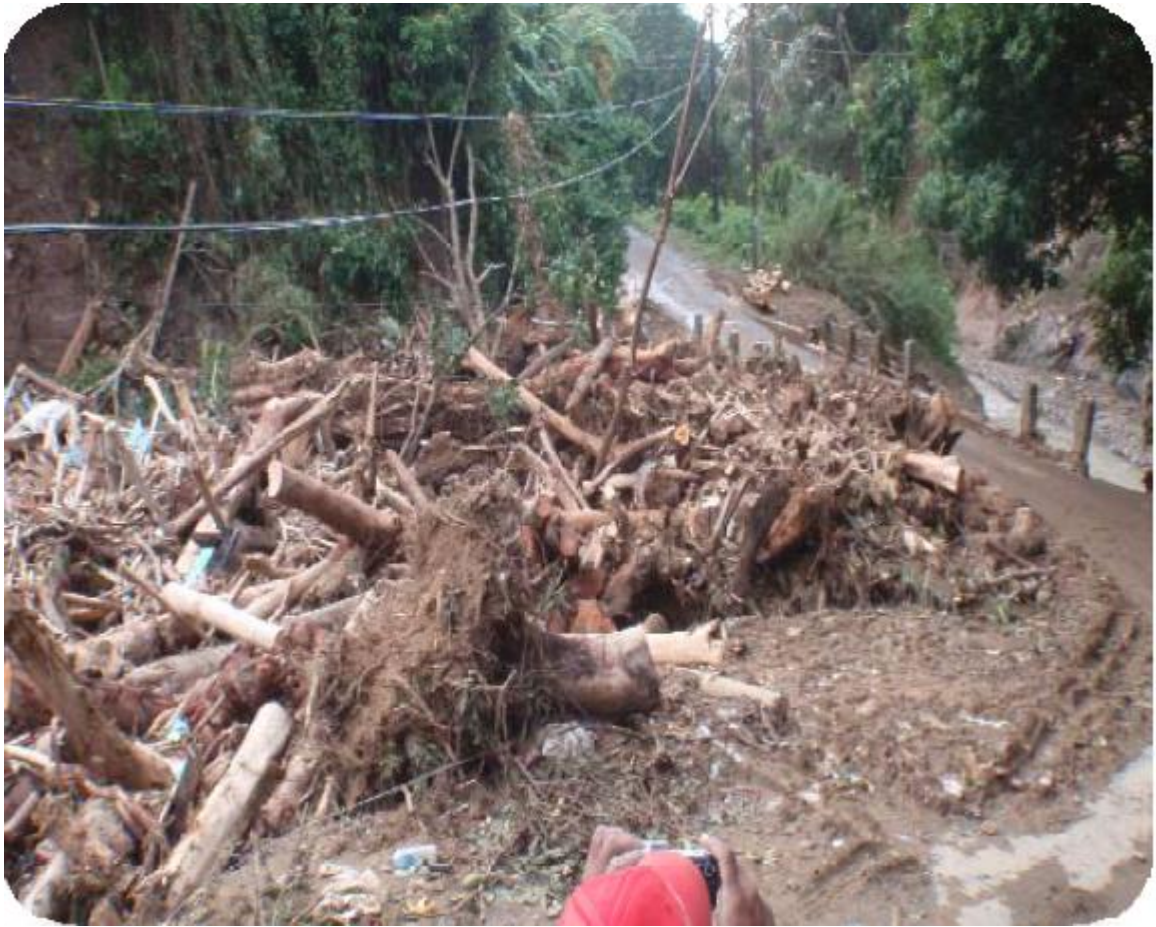
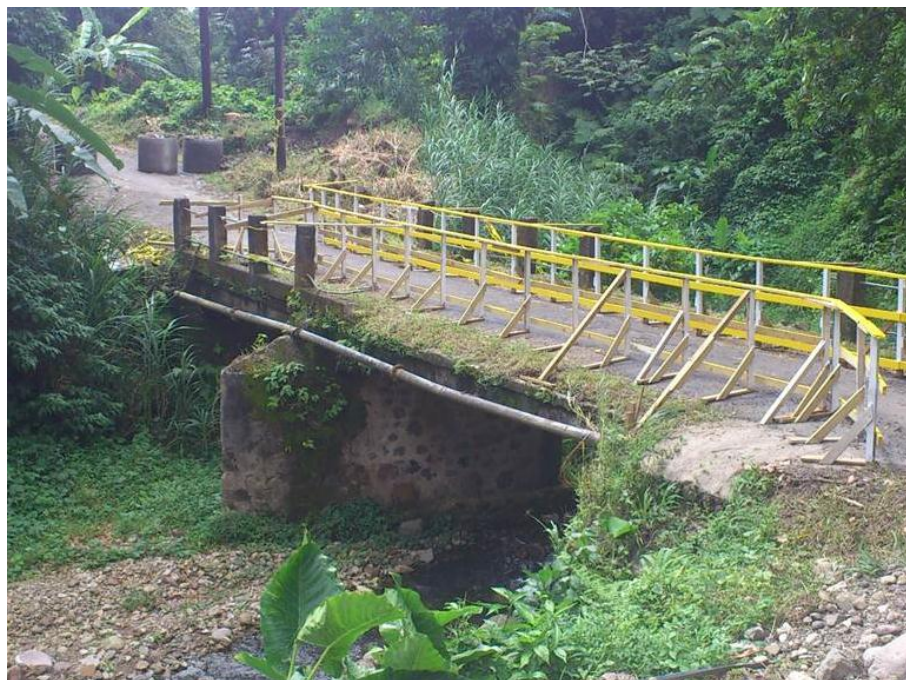
Figure 29 : photographs of Fond Saint Jacques downstream bridge (Mochas' bridge) just after Tomas and after cleaning

- Fond Saint Jacques:
 - Mocha's bridge: it linked Fond Saint Jacques and Bois d'Inde. Tomas damaged this bridge with important tree debris jam. It is now closed to vehicles and authorized only for pedestrians. A new design has been done and the work will occur soon. Expecting data: hydraulic or physical design (Consultant or Ministry?).

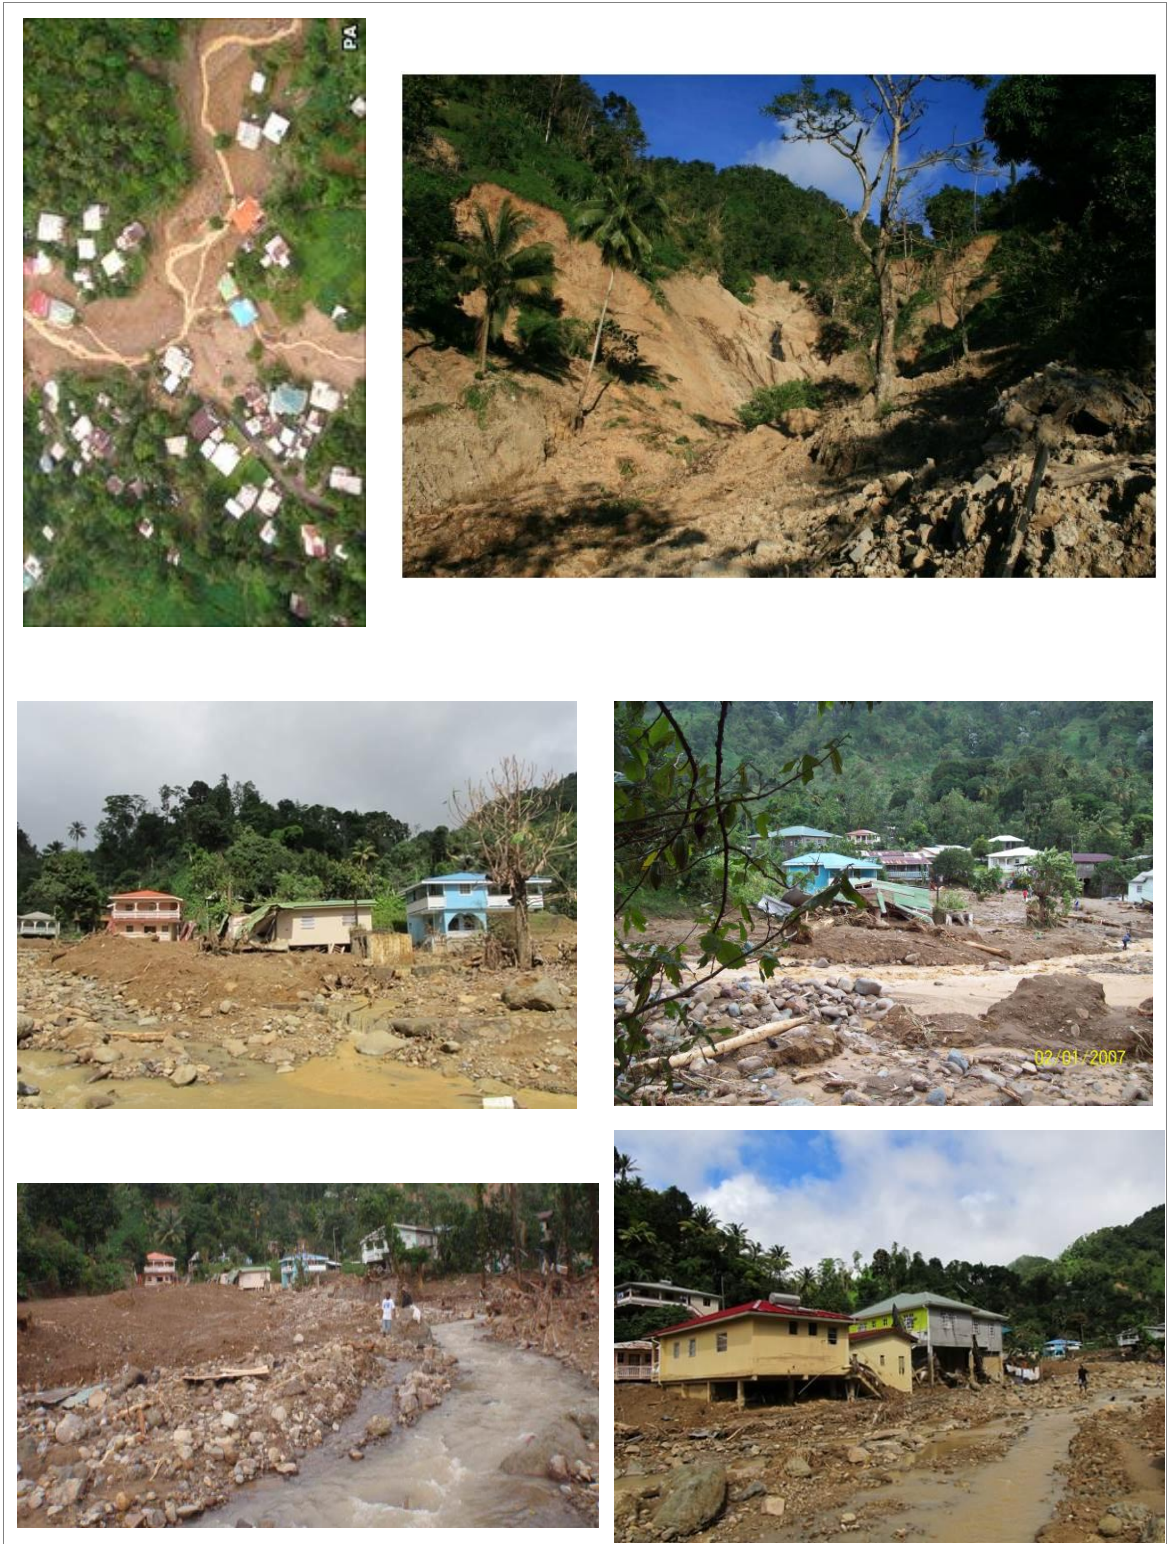
Figure 30 : photographs of Fond Saint Jacques damages just after Tomas

Next photographs were taken by government or consultant (see data collected table) and show the extent of the damage.

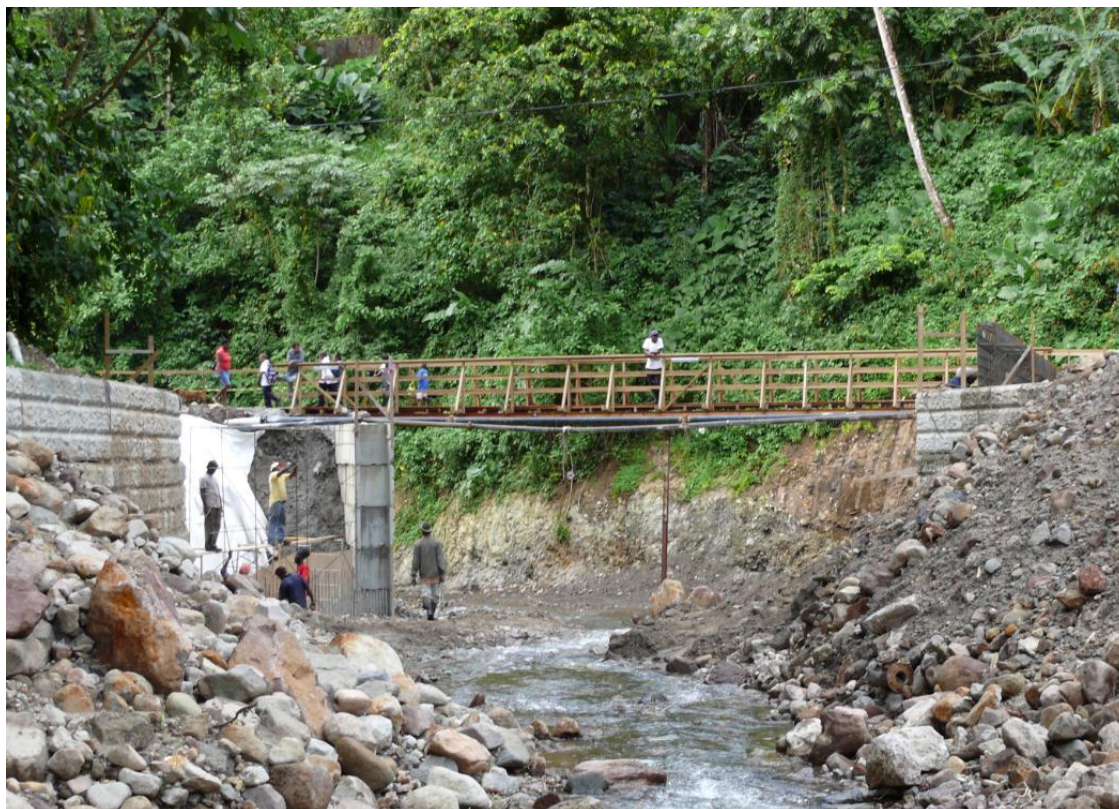
Figure 31 : photographs of actual Mocha's bridge rebuilt

The downstream bridge (Mocha's bridge) was demolished and is presently being rebuilt, without a central pier (see below).

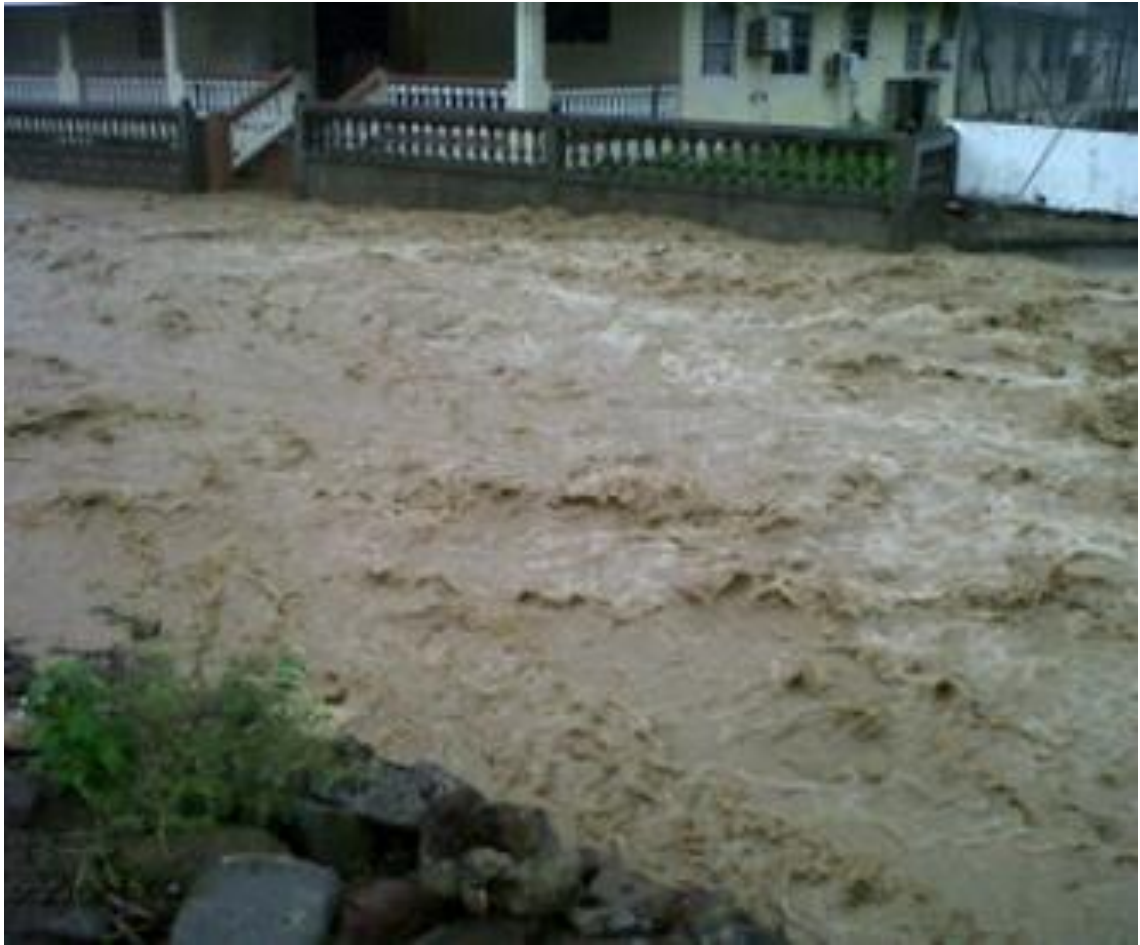
Figure 37 : Soufriere River beside the hospital during Tomas

The main problems during Tomas hurricane were caused by water flow, debris flow and high sea level.

Indeed, debris flow provided big jams problems under each bridge and footbridge across the river and caused flooding and infrastructure damages.

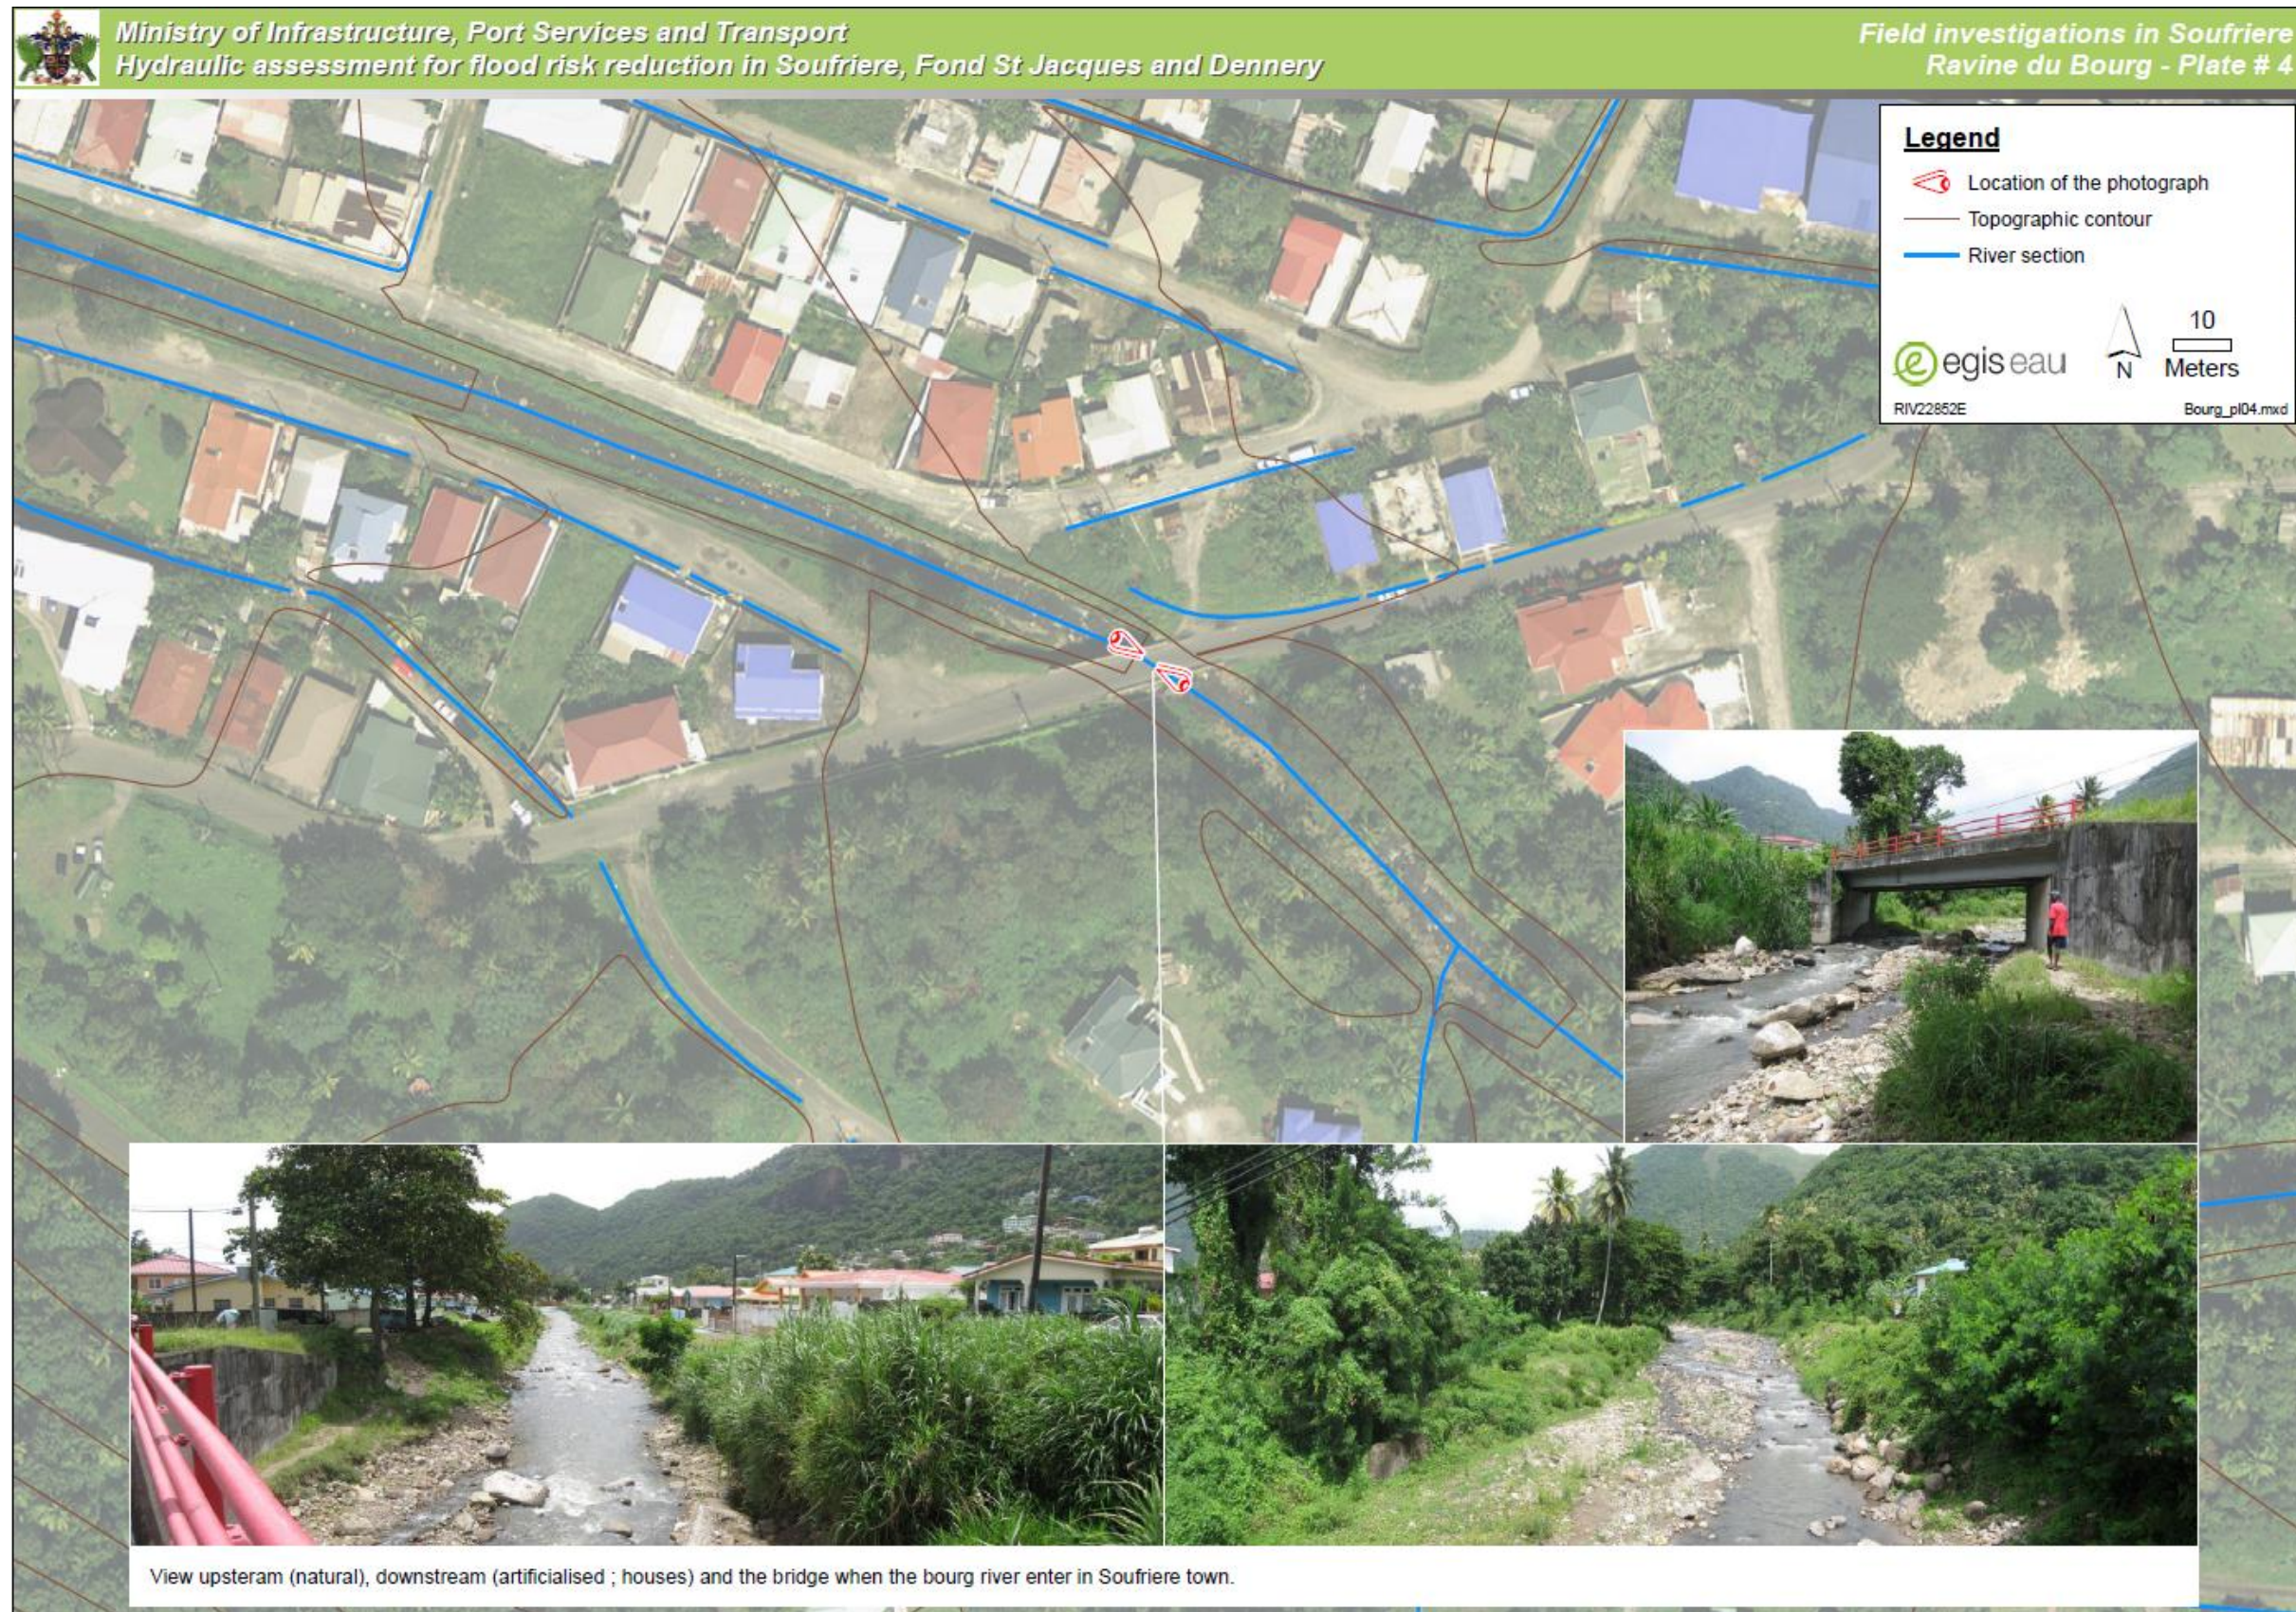
Figure 43 : Field Investigation in Soufriere : Plate # 4

View upstera (natural), downstream (artificialised ; houses) and the bridge when the bourg river enter in Soufriere town.
