Hurricane Tomas Emergency Recovery
Project

Hydraulic assessment for flood risk assessment in Soufrière, Fond St Jacques and Dennery

Report # 1: Site characterization, Flood Hazard and Vulnerability Analysis

December 2013

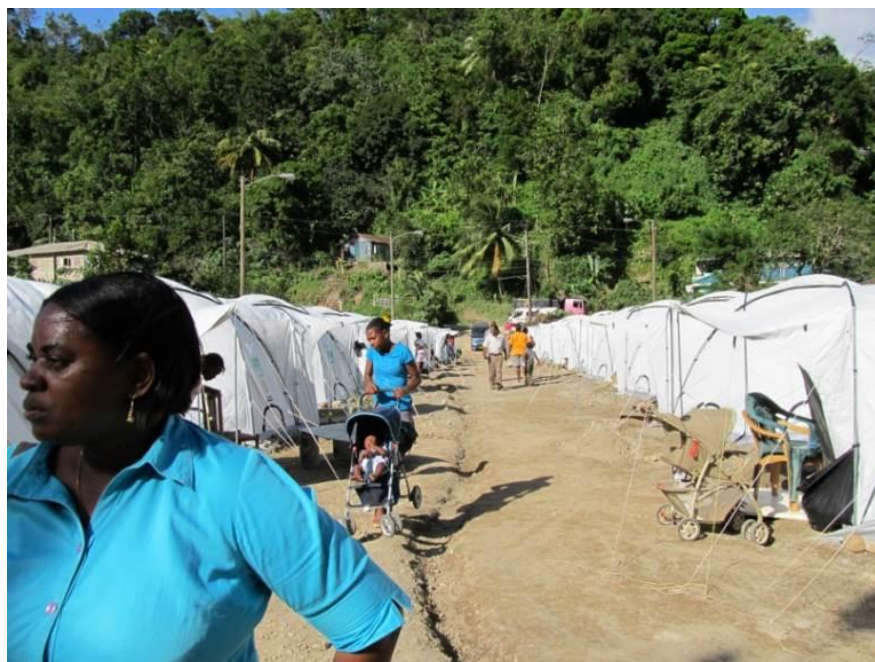
Fond Saint Jacques community (estimated to 230 people) was particularly damaged by landslides (38 houses damaged) and the government provided tents for temporary housing.

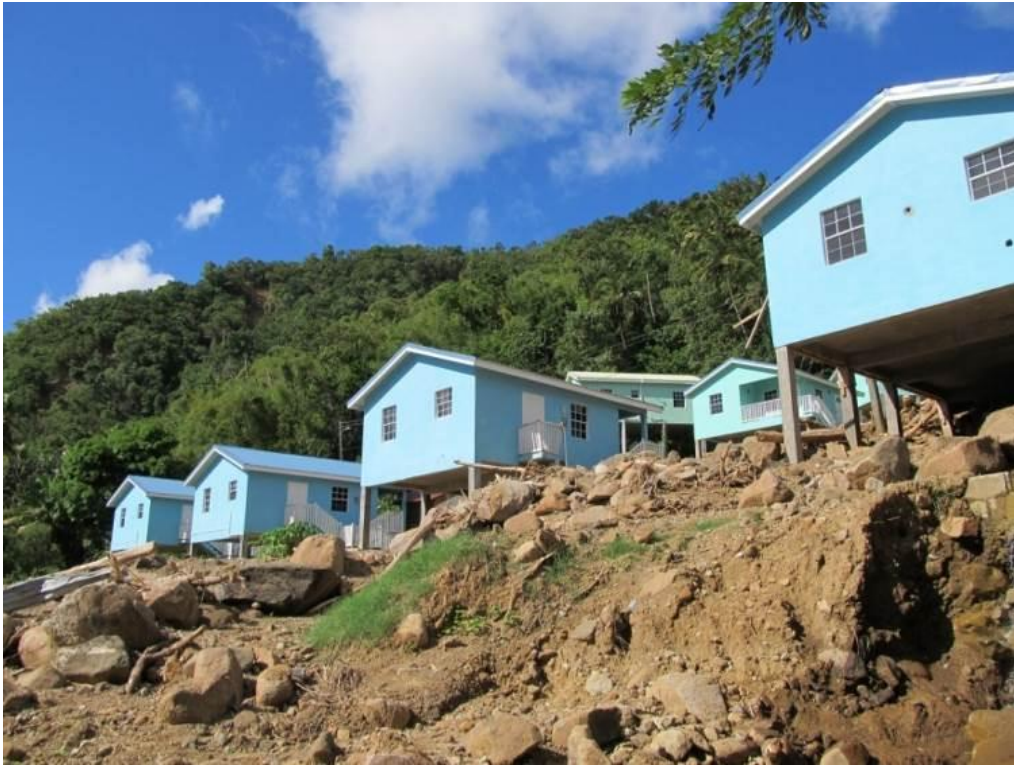
In Crestland a housing project started before Tomas had to be canceled because of landslides:

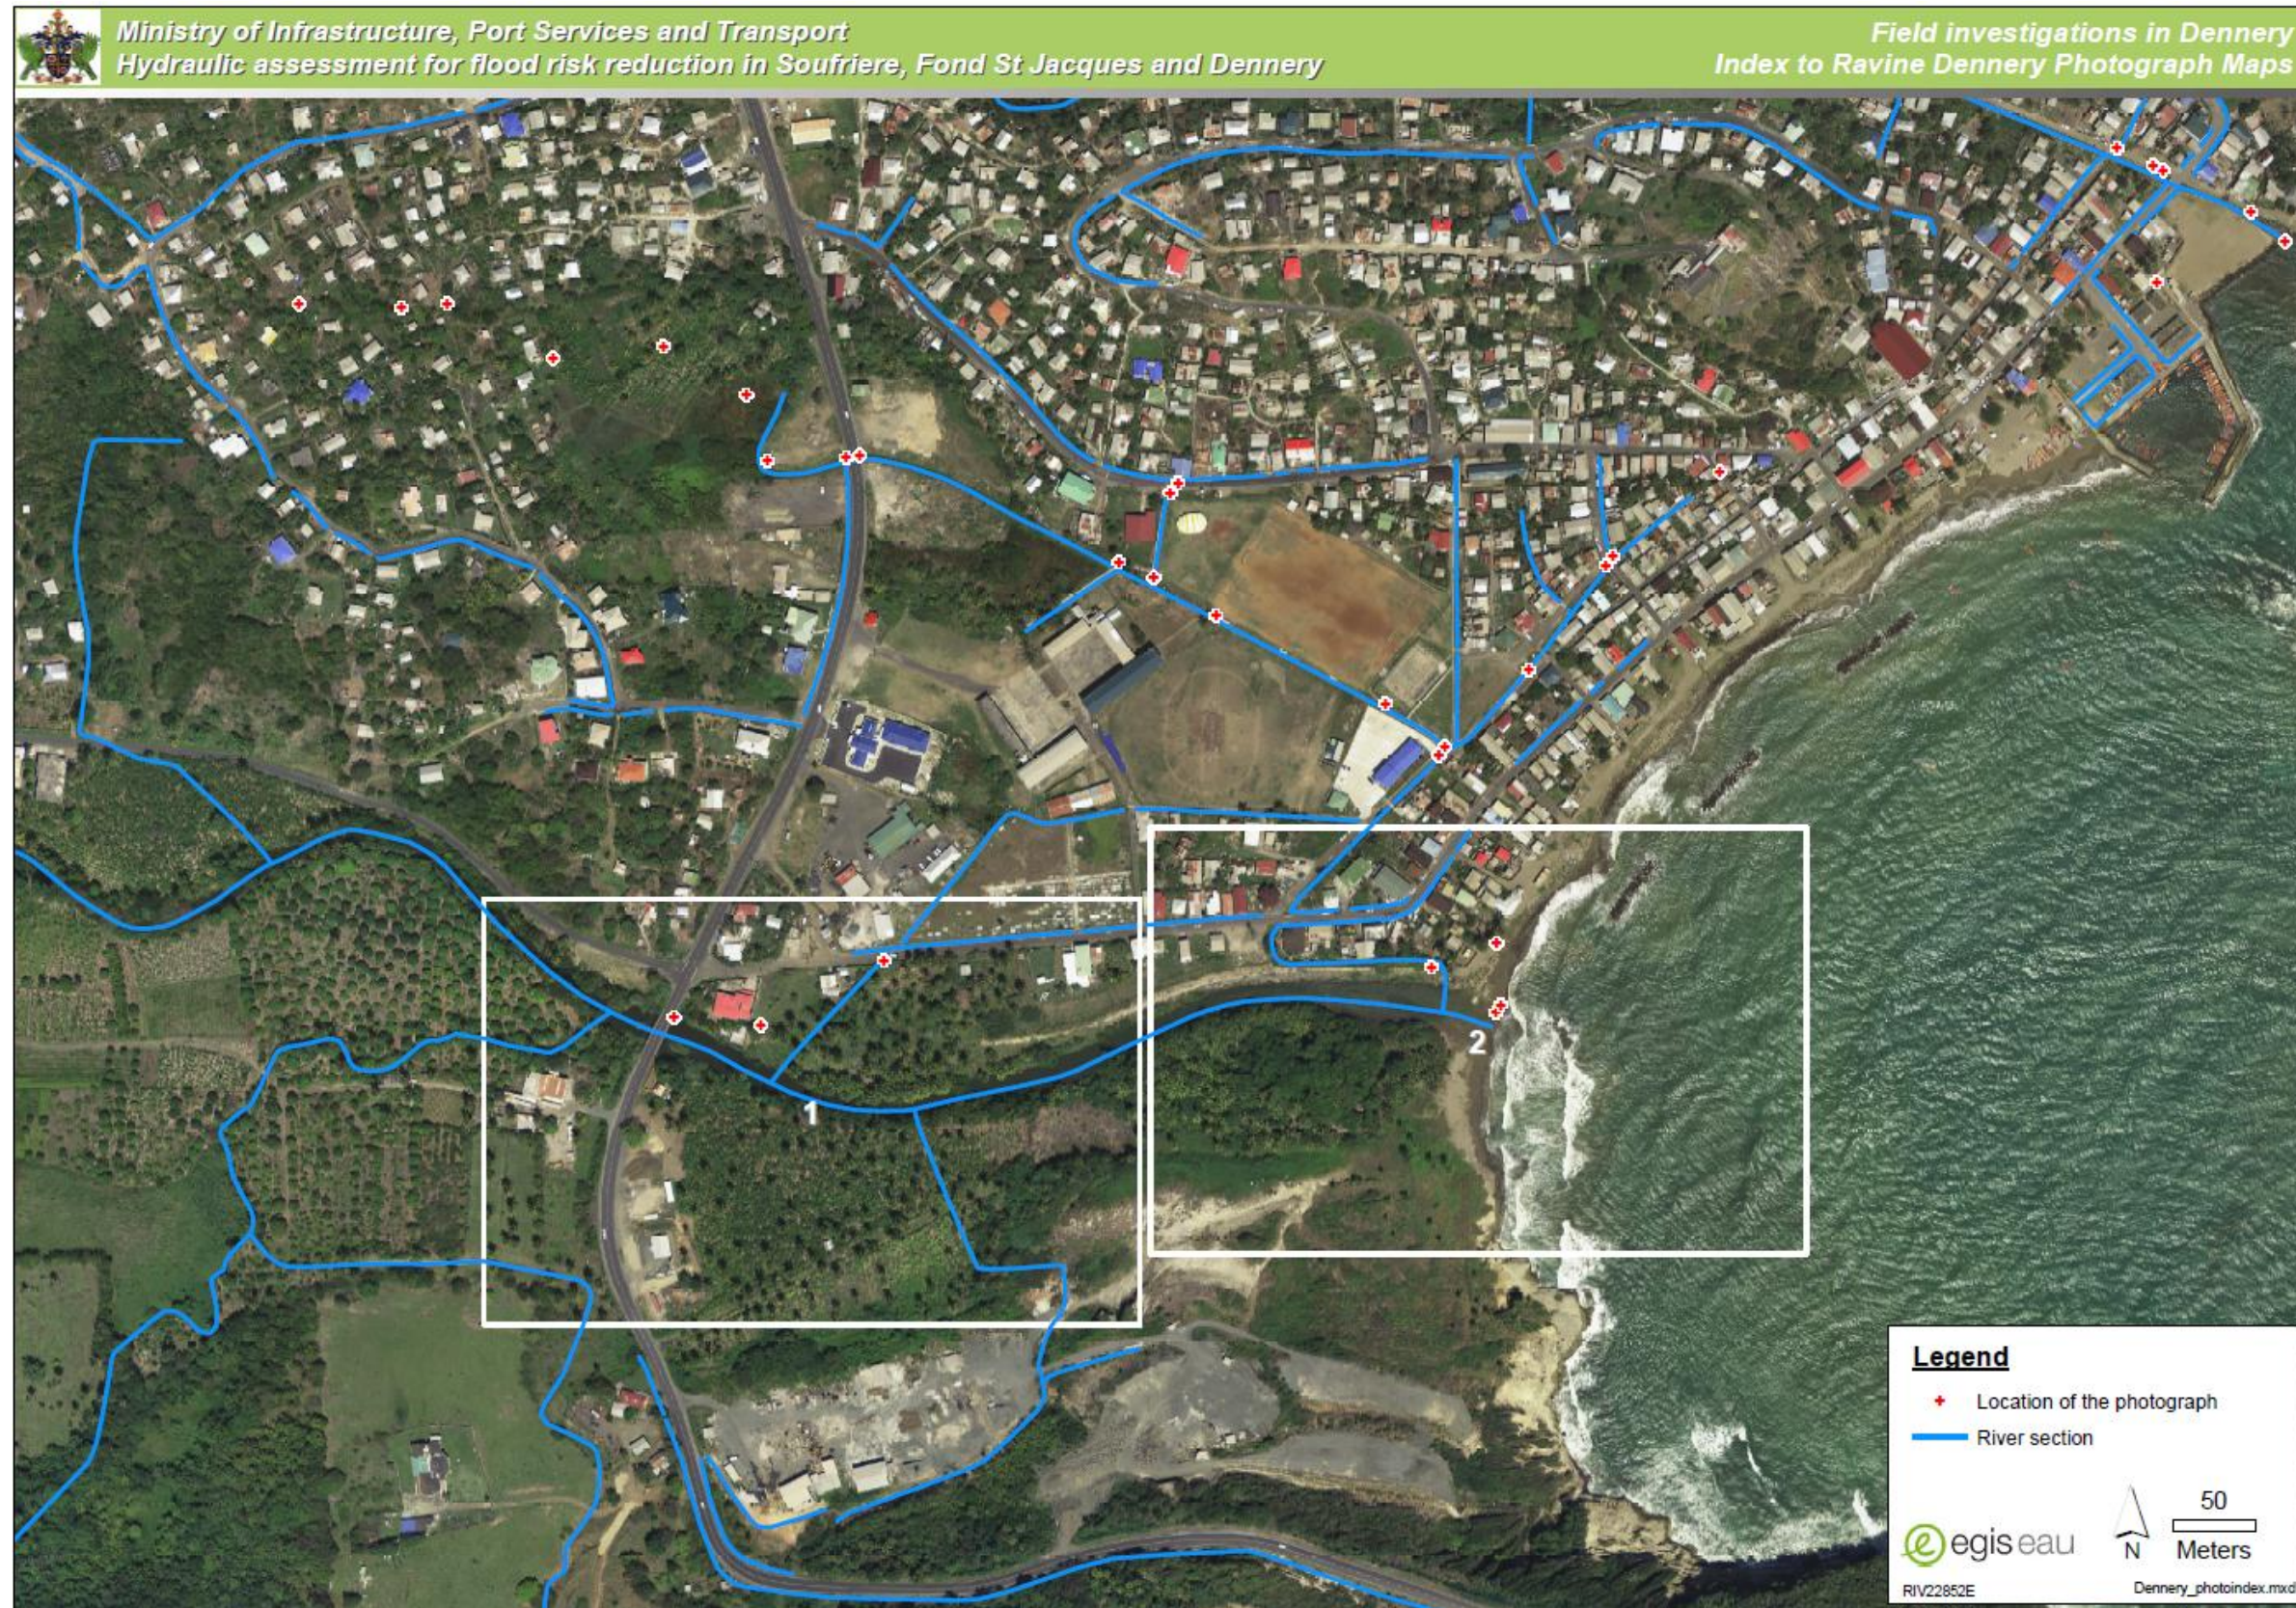
Figure 25 : Field Investigation in Dennerly : Ravine Dennerly – Photograph index

The outlet of central Drain was damaged by the flow during Tomas.

The bridge wasn't overflowed during Tomas and wasn't damage.

This bridge has a central pier which leads to accumulation of debris upstream. This may cause local hydraulic disturbances.

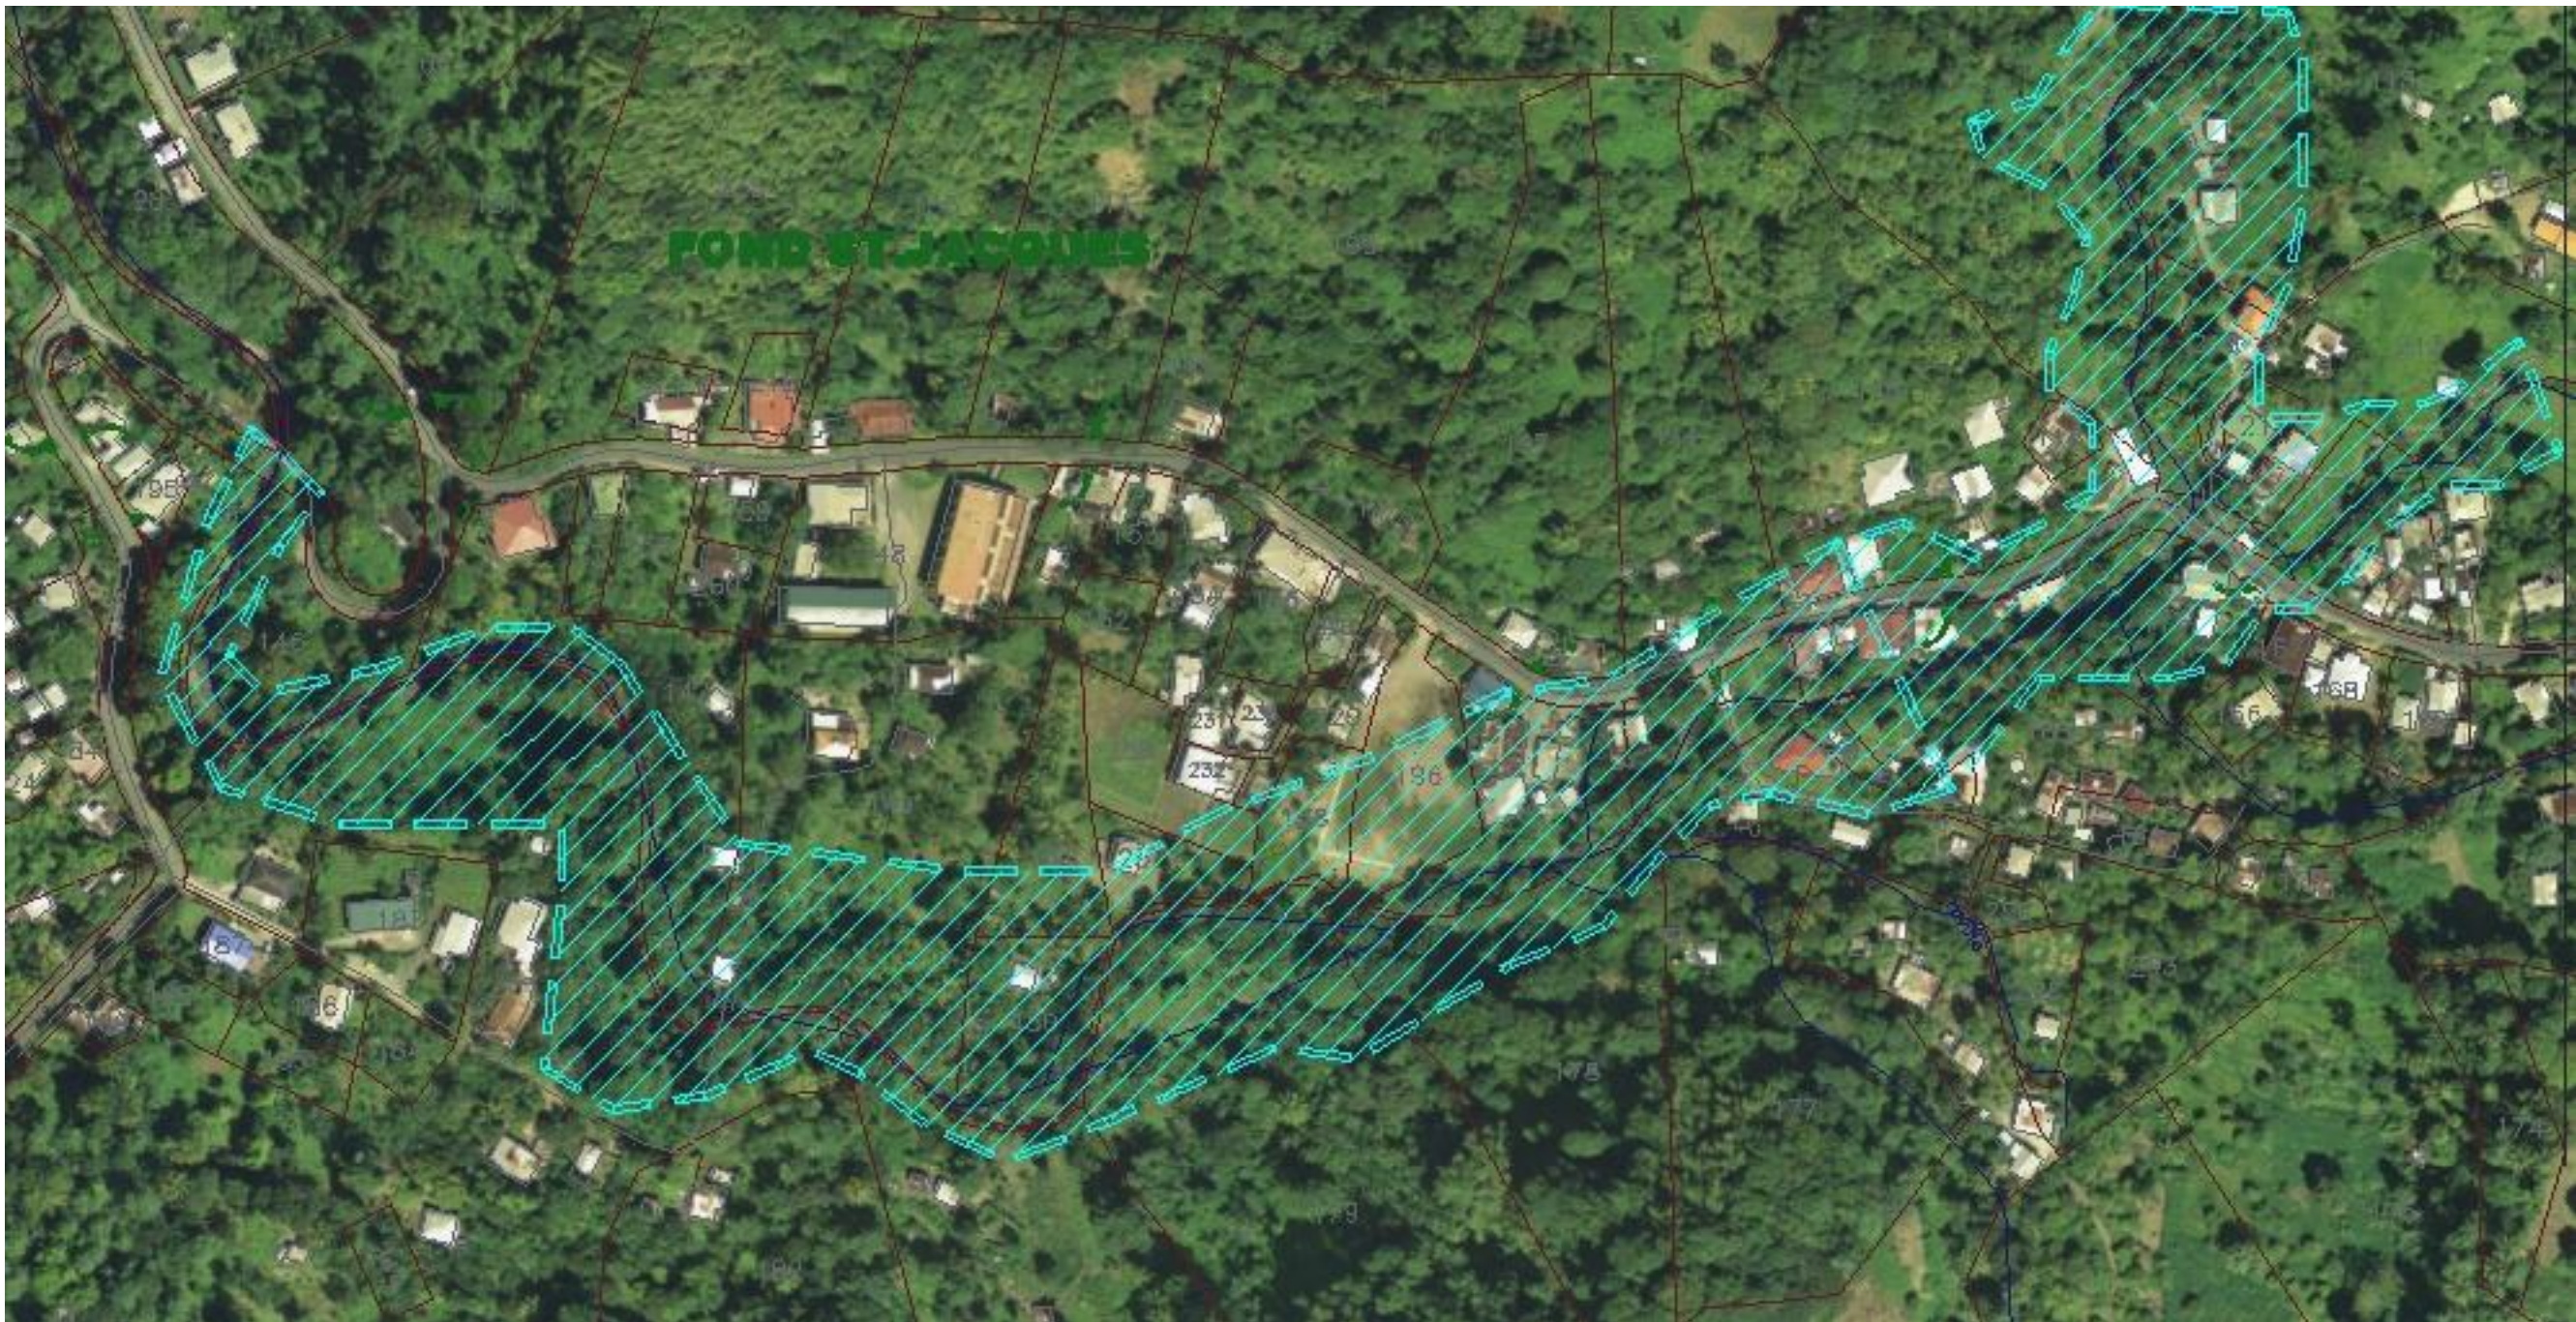
Figure 53 : Fond Saint Jacques floodplain (field investigation)

The floods in Fond Saint Jacques are “flash-floods” and “mud-floods” caused by heavy rain on the rainforest steep sloped catchment. The velocity is very high and the water levels can reach the 2nd floor of houses built too close from the waterway.

The Fond saint Jacques field investigations highlight the flood risk increase resulting from unplanned development (construction in the bottom of the valley too close from the waterway) and improper forest management.

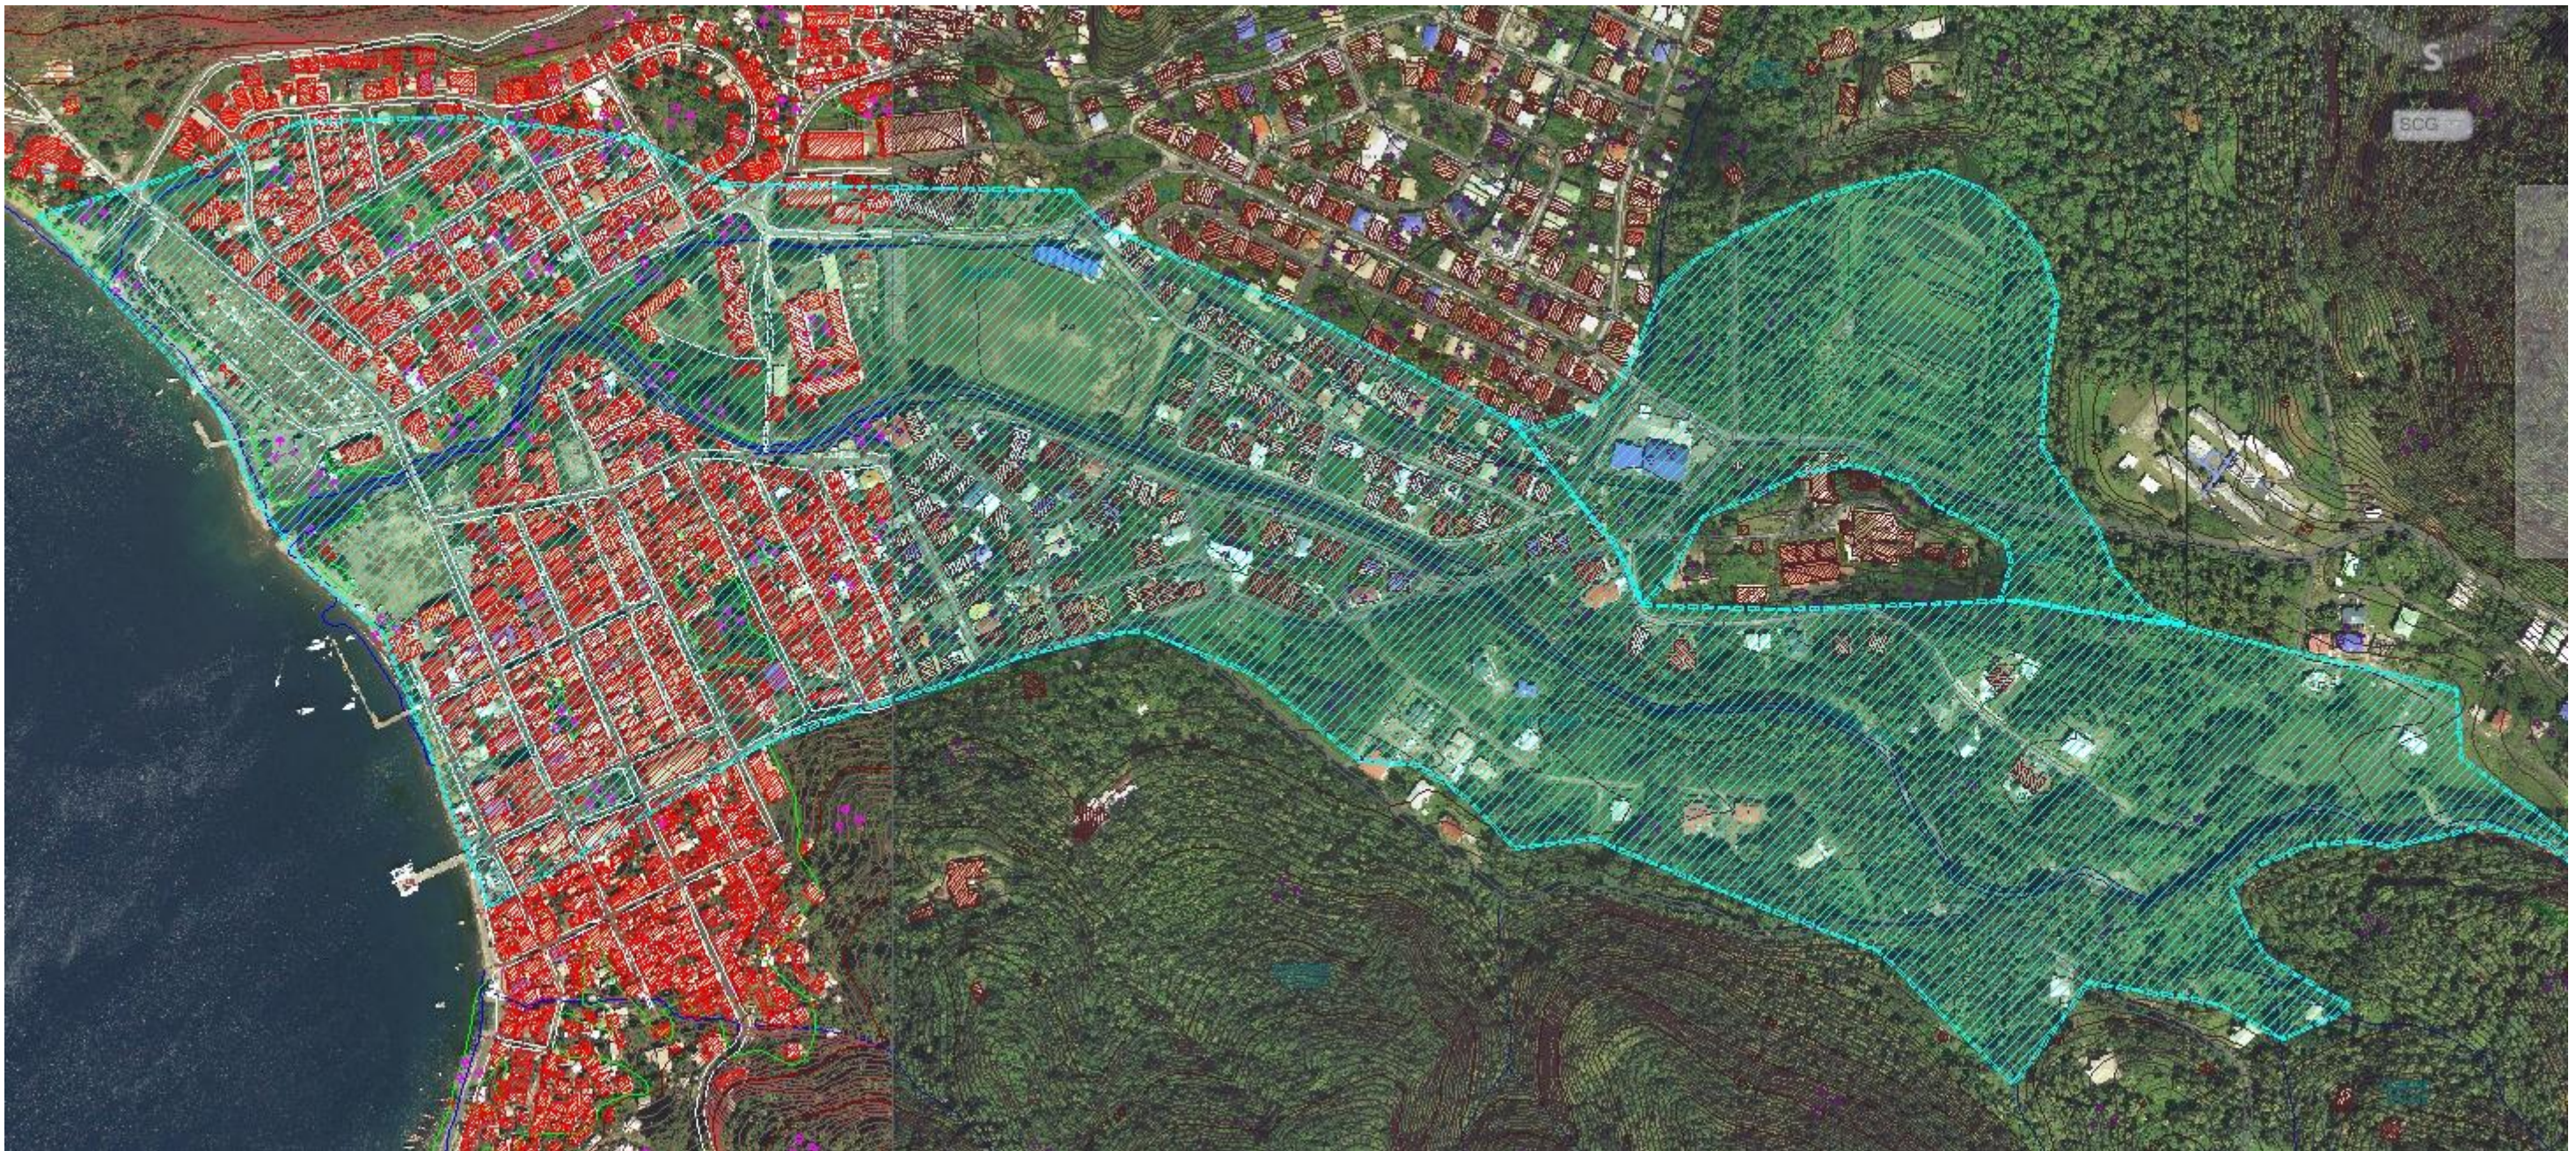
Figure 54 : Soufriere floodplain (field investigation)

The main problems during Tomas hurricane were caused by water flow, debris flow and high sea level.

Indeed, debris flow provided big jams problems under each bridge and footbridge across the river and caused flooding and infrastructure damages.

The two footbridges were submerged and destroyed during Tomas. They are now rebuilt, higher than before. The bridges upstream and downstream have been rebuilt too after Tomas because damaged during the flood.

After Tomas, the waterway has been dredged, and all the rocks are now deposited along the channel bank. If another flash flood happens those rocks would cause a lot of damages.

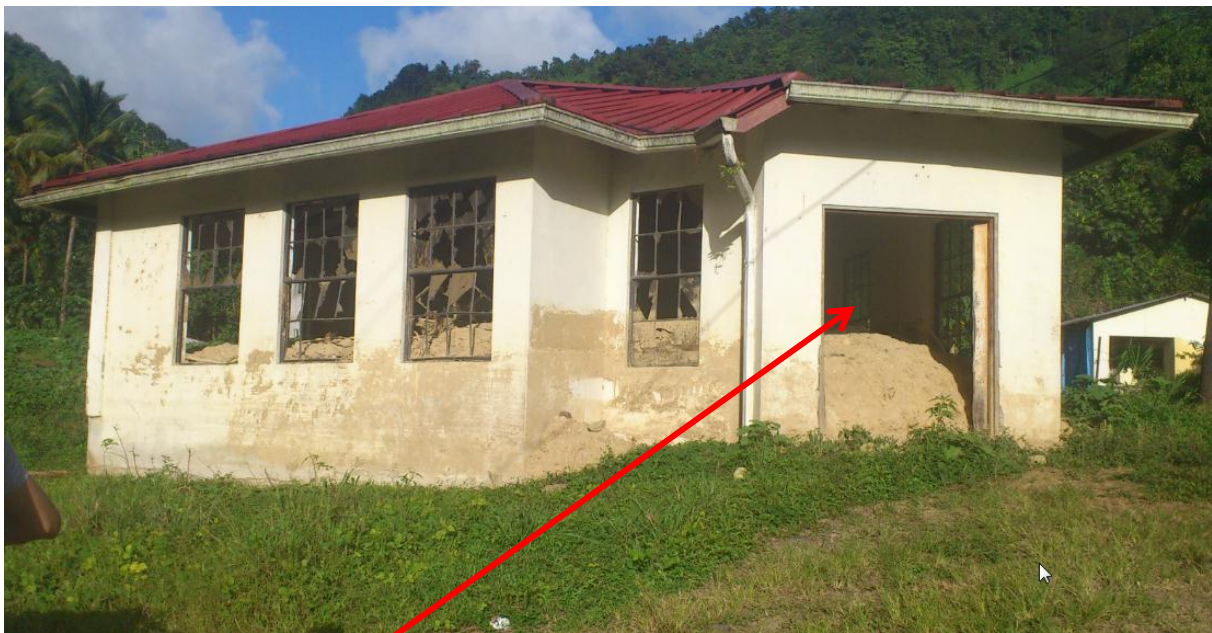
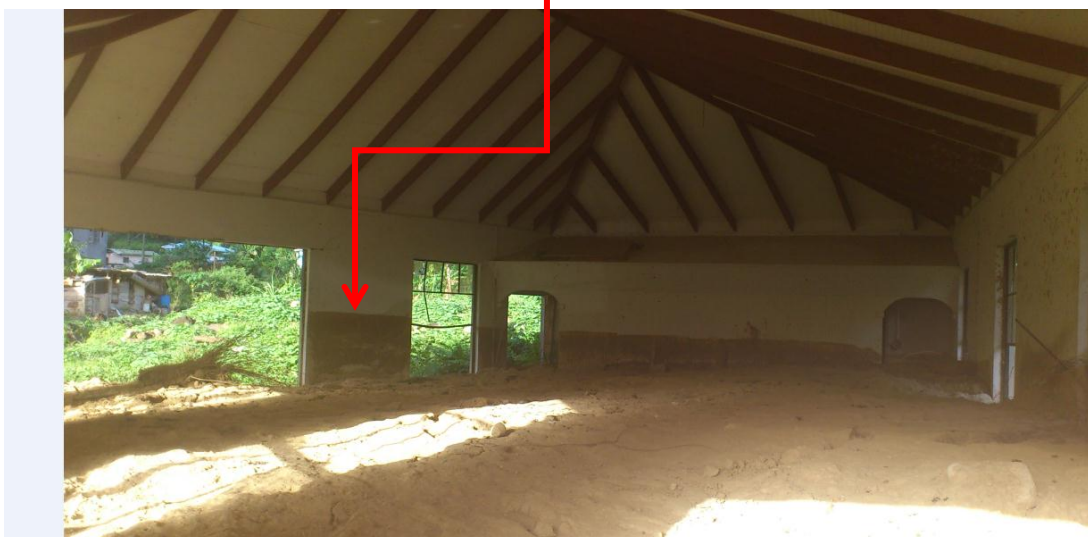
Water Level 1 Fond St Jacques	P
Latitude :	13°50'8.36"N
Longitude :	61° 1'24.63"O

Take the highest level of the mud and the dirt level inside the house

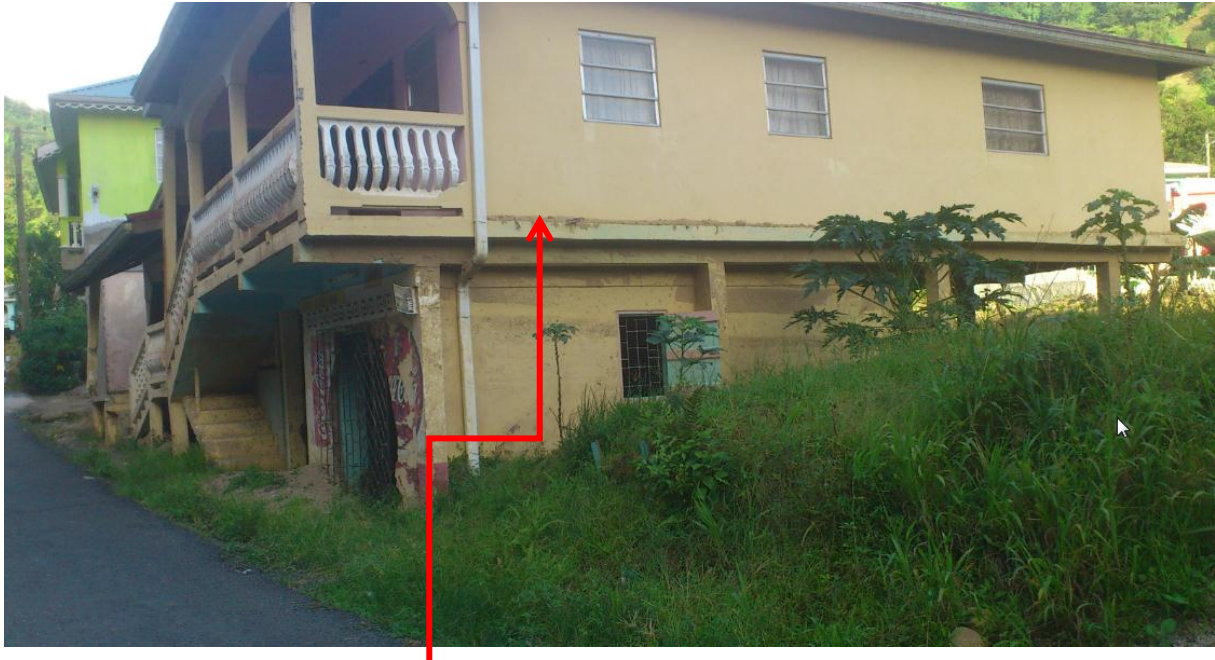
Water Level 2 - Fohd Saint Jacques

Take the level of the mud at the first floor

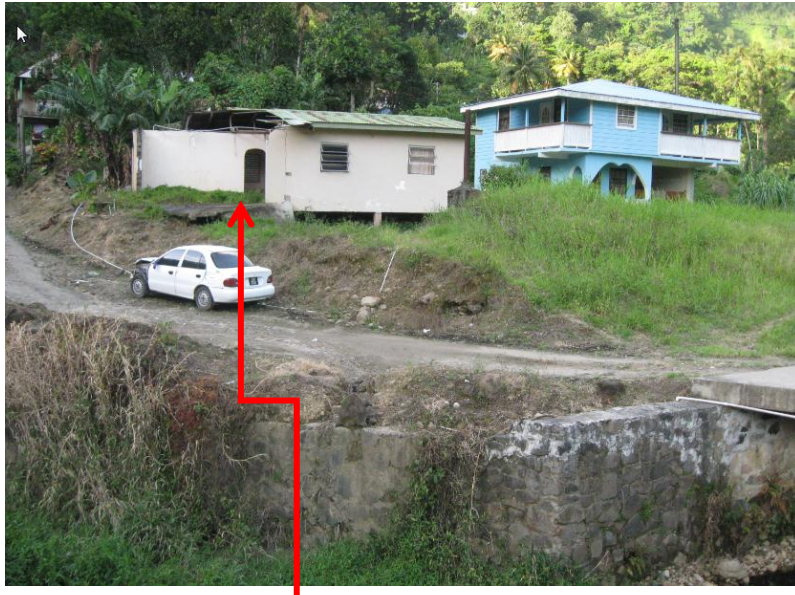
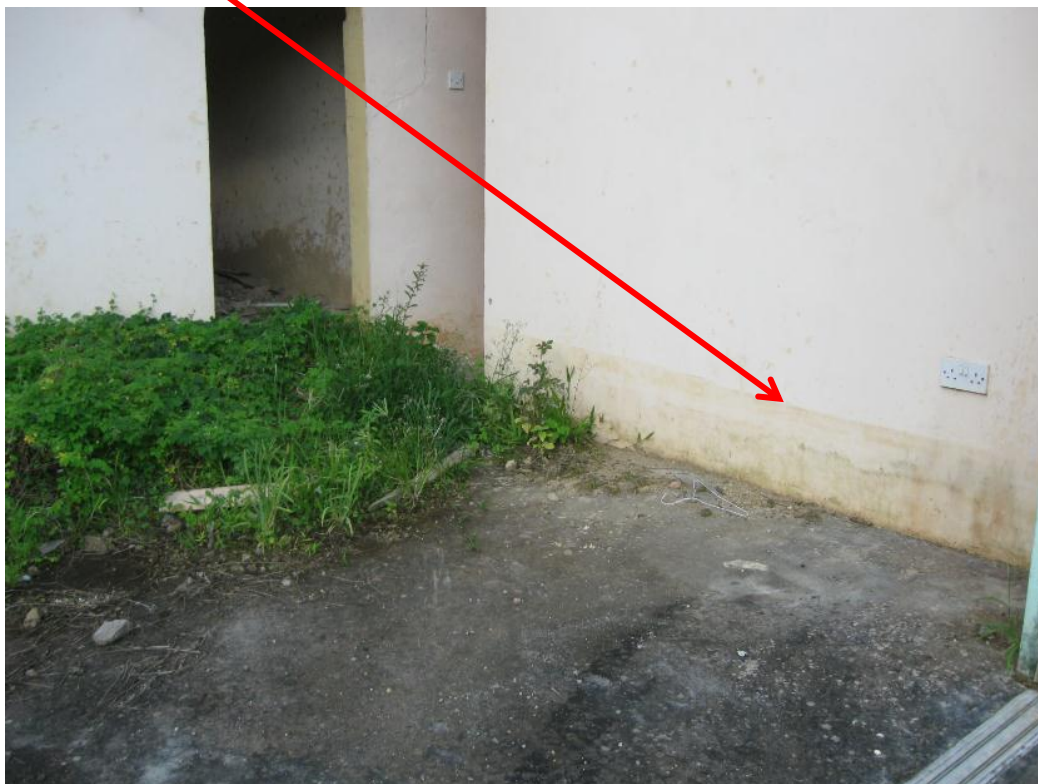
Take the level of dirt inside the broken house

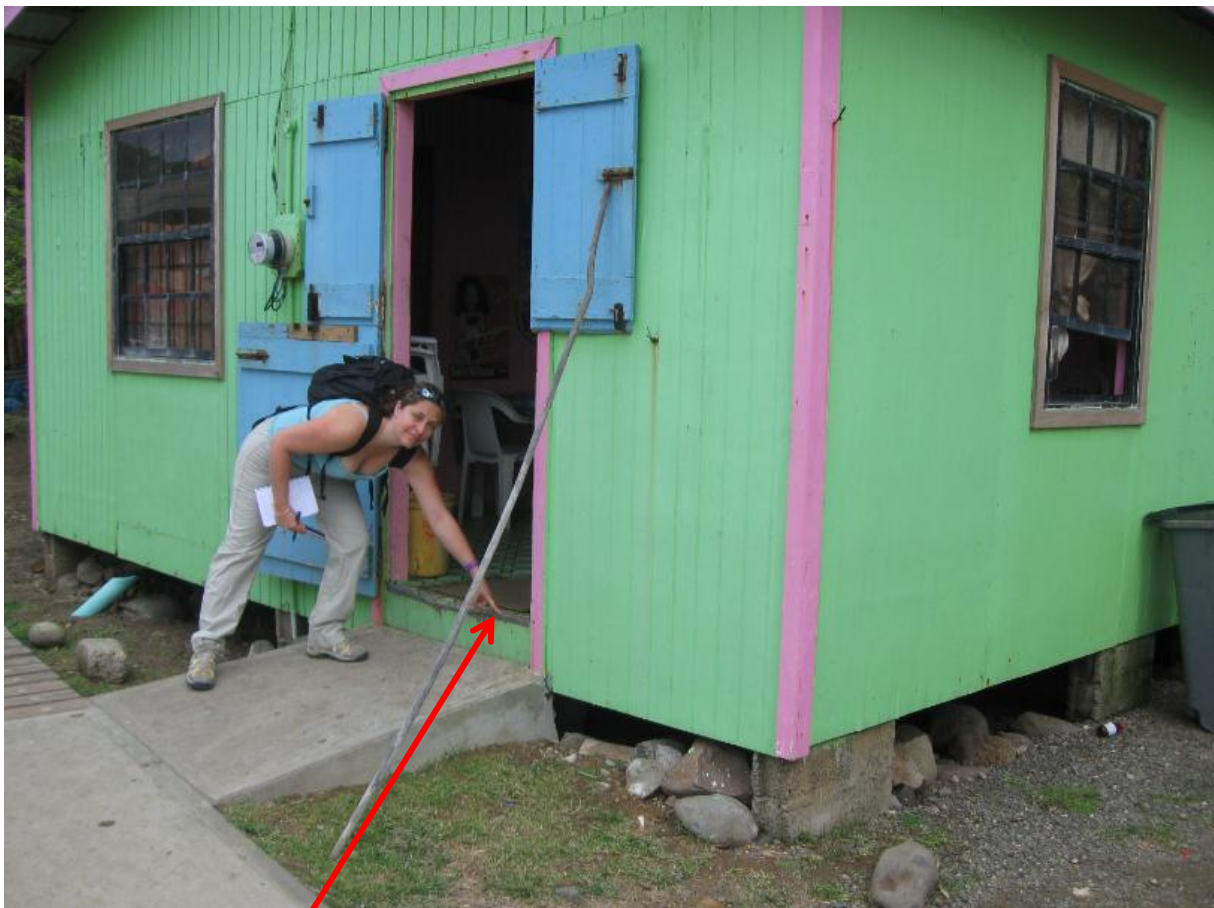
Water Level 1 - Dennery		P
Latitude :	13°54'43.64"N	
Longitude :	60°53'12.98"O

Measure the floor level of the restaurant

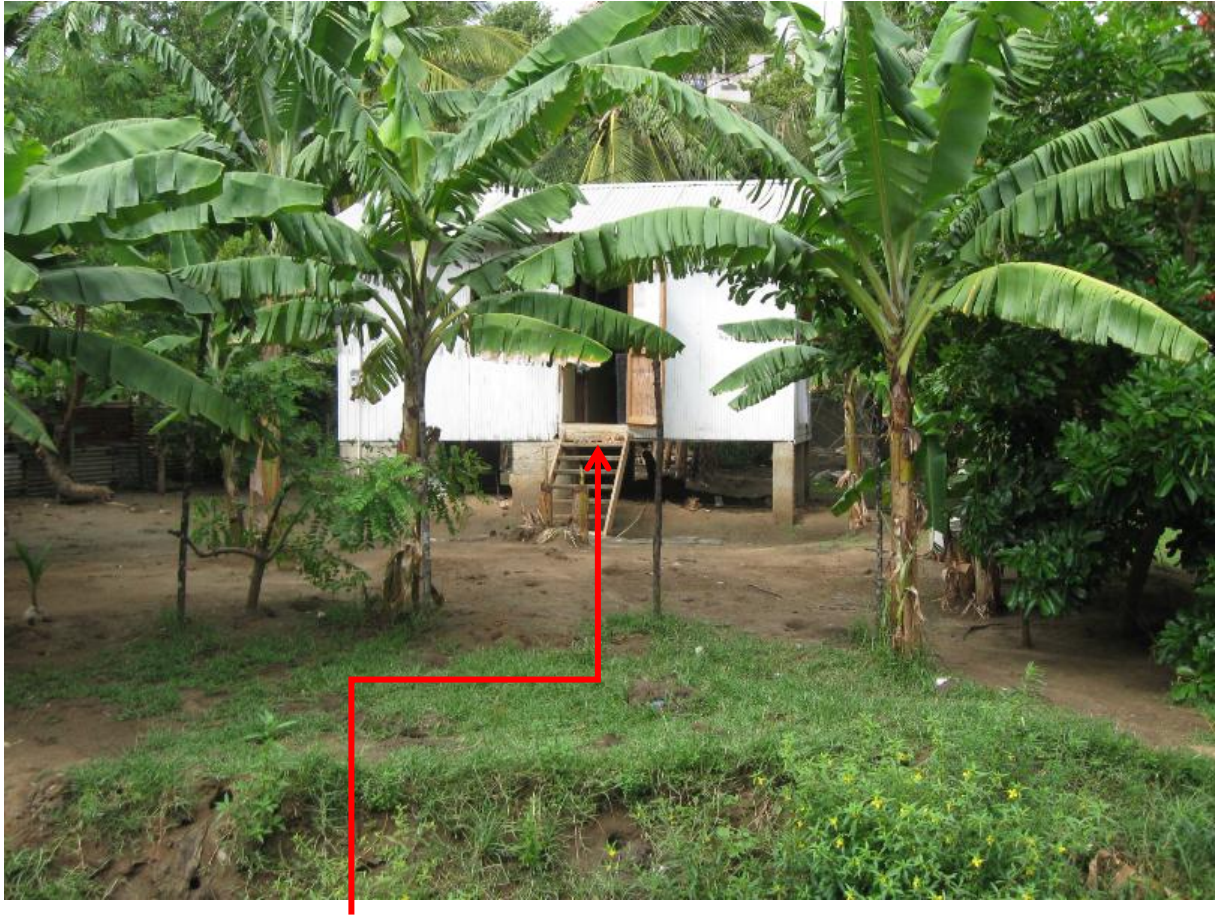
Measure the level of the last stair before the floor of the house right bank

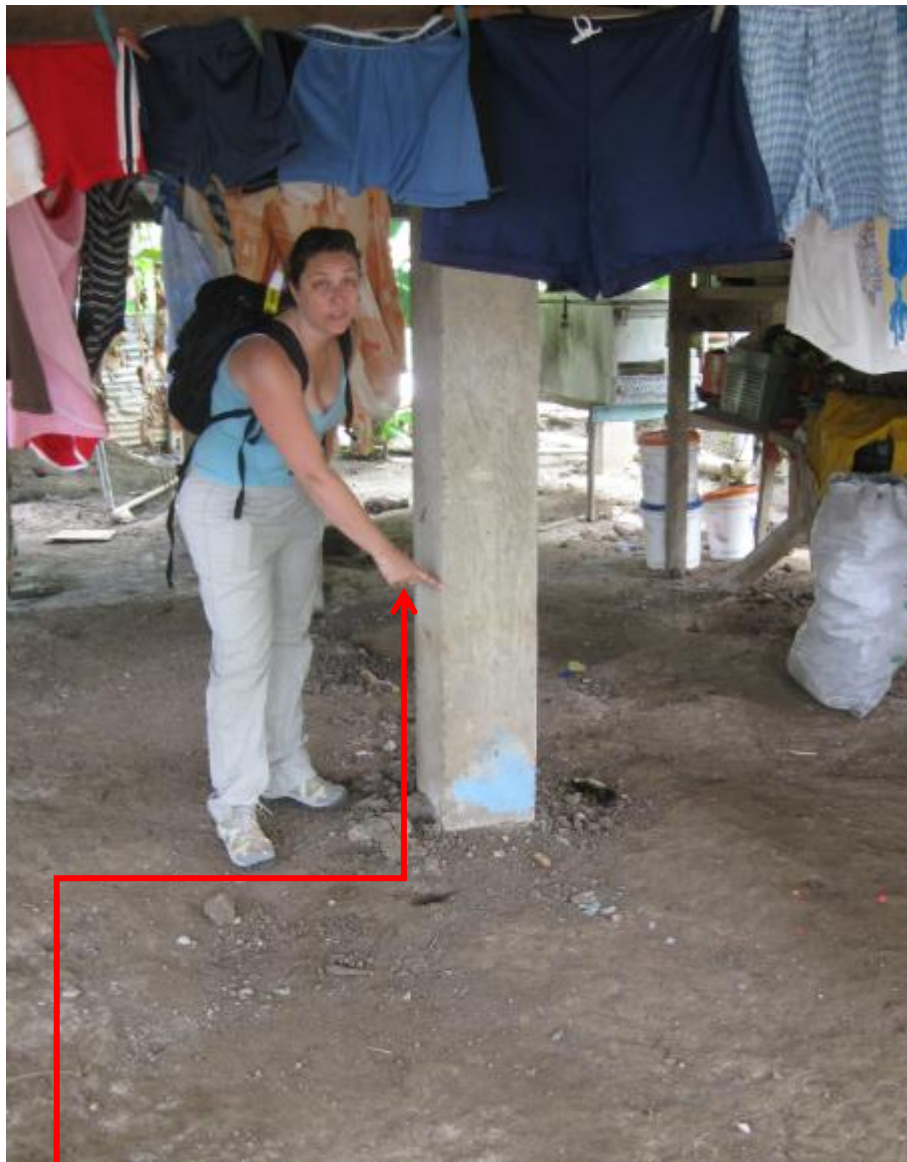
Measure the level shown on the pilar with the blue trace under the house left bank

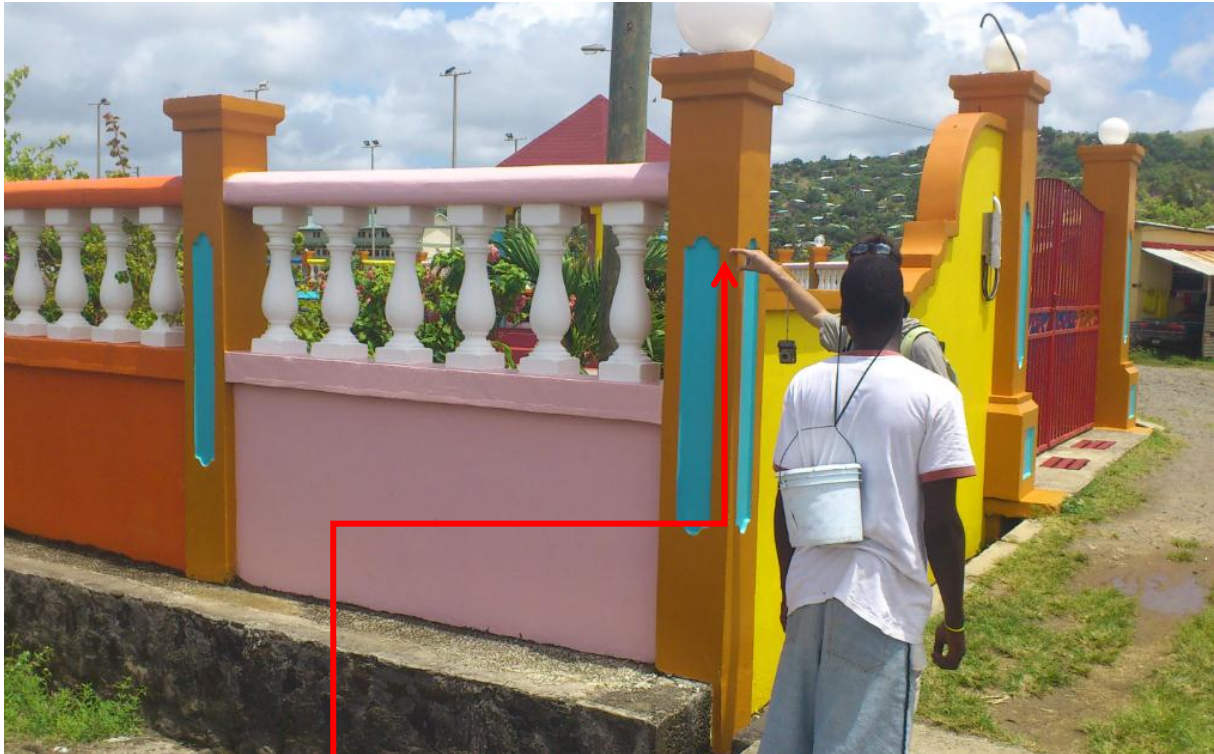
Measure the level shown
